## Genuine Lexmark C782 Brand Laser Cartridges vs. Three Brands of Remanufactured Cartridges

APRIL 2012

Buyers Laboratory LLC (BLI) was commissioned by Lexmark International Inc. to conduct an independent comparative lab evaluation of the performance of new Lexmark brand extra-high-yield print cartridges against that of remanufactured brand cartridges in the Lexmark C782 color laser printer. Test cartridges for the following three representative remanufactured brands were obtained on the open market: NewproNet, TonerBoss and Sun Data Supply.

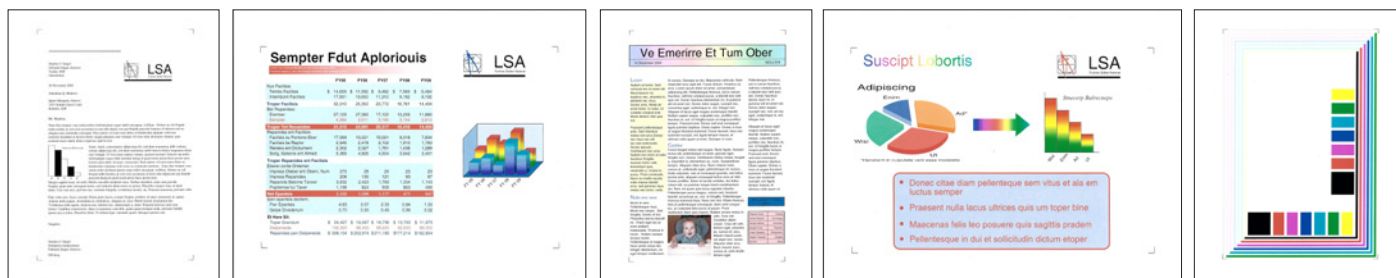
Exhibit A: ISO 24712 Test Suite

Approximately 467,000 pages were printed during the test. Nine cartridges of each color from each brand were evaluated across three printers, so that three cartridges per color were tested in each printer. The cartridges were run to end of life utilizing the five-page ISO 24712 color test file intended to be representative of typical customer usage (see Exhibit A below), during which time page yield, image quality and reliability performance were evaluated. Following the completion of testing for each brand, the printers were cleaned and serviced with new transfer belts, rollers and fusers. Waste toner containers were changed when prompted.

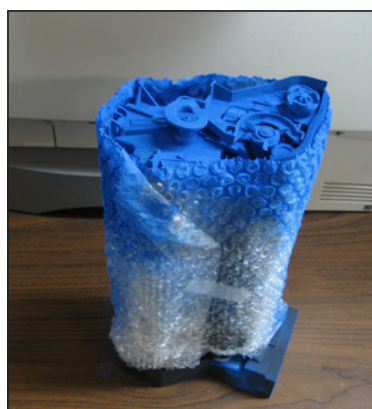
### EXHIBIT E: Excessive Toner Dumping

- Blue dots on the side of pages (1)
- Red dots on side of pages (1)
- Physical cartridge damage (3)
- Non-recognition of cartridge by printer (1)
- Excessive toner coverage (5)
- Excessive toner dumping out of box (1)
- Red lines on the side of pages (1)
